Long Term Performance of PVC Pressure Pipes

The Millewa Waterworks District Scheme, in North Western Victoria, was a major project undertaken to replace an open channel domestic and stock water distribution system with pipelines.

After almost 30 years of successful operation, samples of PVC pipe were exhumed for testing, to determine whether there had been any deterioration in the quality of the pipes during their service life.

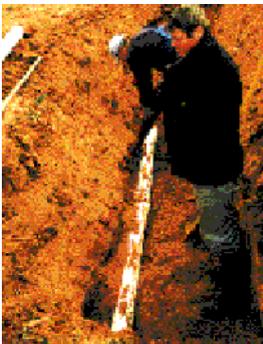
Typical trench conditions are illustrated in the photo at left.

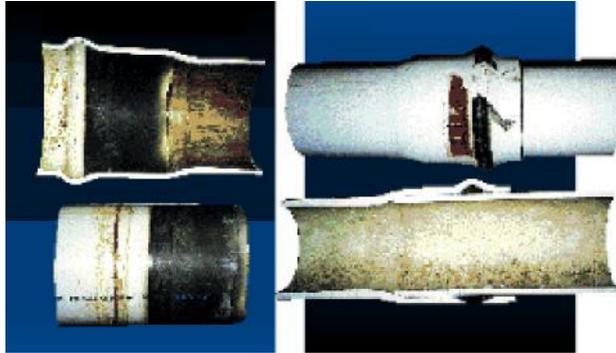
Elastomeric seal joints as exhumed and subsequently sectioned are depicted below.

Vinidex
Polidex Rubber Ring Joint

Hardie
Rubber Ring Joint

Dark staining is evident on the matching socket and spigot surfaces where the water would be essentially dormant. This staining is likely to be due to sulphides reacting with the lead stabiliser in the pipe. The staining is only a surface effect.

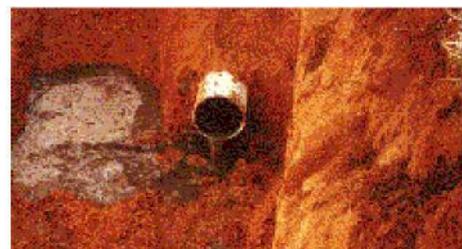
Some pipelines are currently "contaminated" by a grey "sludge", as can be seen in the photograph shown at right.

This material is thought to be at least partly composed of dead organisms and has had no apparent effect on the performance of the PVC pipes.
