PVC tops pipe joint performance tests

In tests conducted by the CSIRO Building, Construction and Engineering Division, to measure the performance of various pipe materials to root penetration, PVC pipes came out with a perfect score in that there was nil root intrusion in any of the samples tested.

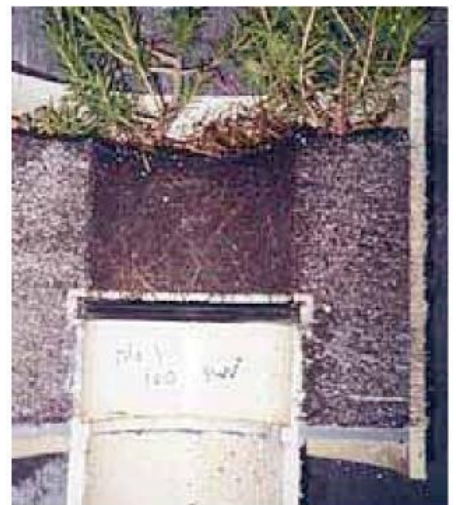
TEST HIGHLIGHTS:

Root penetration accelerated trials over a 32-month period:

This compares with penetration of 87% for vitreous clay pipes (VC) and 37% for fibre reinforced concrete (FRC) in accelerated trials over a period of 32 months.
